2 MOTOR GRADER TEST

Warco Grader - Model 4D-100,

San Bernardino and Angeles National Forests

January 17 - February 8, 1951 //

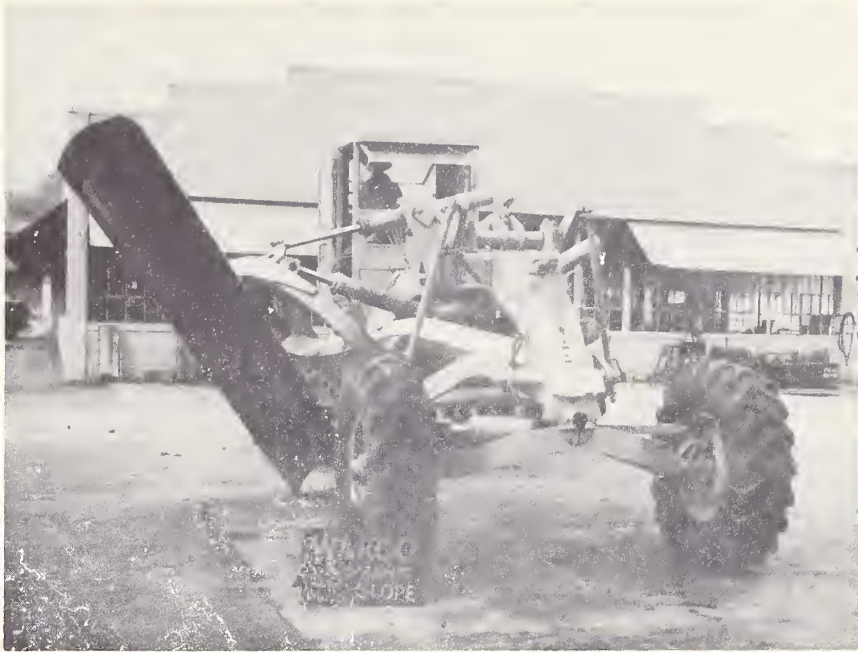
Fig. 6. $3/4$ to 1 Blade Position

Figure 6 shows blade set for a $3/4$ to 1 bank sloping position.
Figure 7 shows the completed bank slope job for $3/4$ to 1 before final pass was made to clear up the road bed.

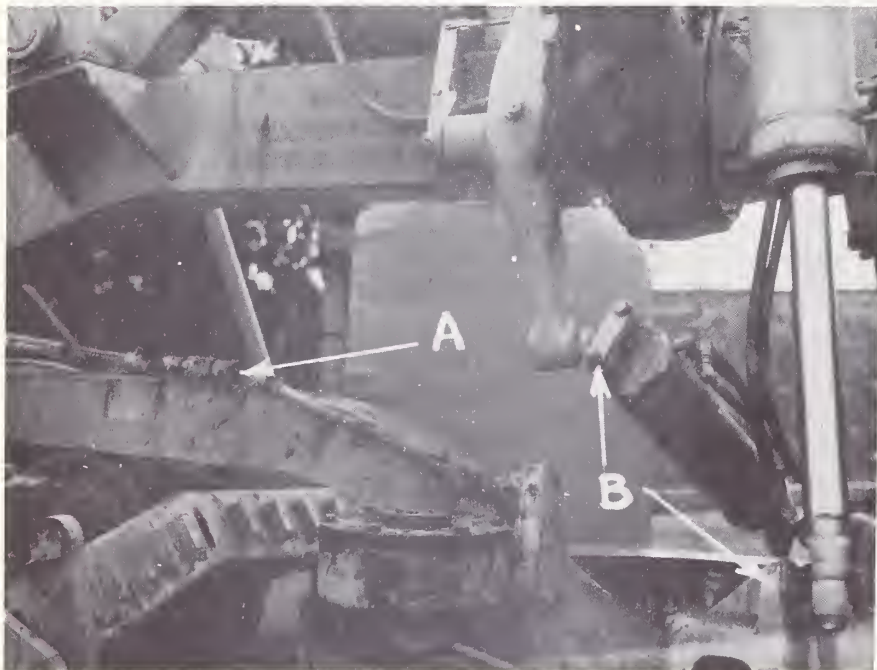
Fig. 18. Left Front View

Arrow A, in Fig. 18, shows connecting linkage from circle drive motor to the gear reduction box of the circle assembly. Wear in universal joints was considered as above normal. It was recommended that the hydraulic motor be moved to a mounting spot on the drawbar so as to eliminate these universals and support bearings. Arrows B indicate a point of interference of the crossarm of the drawbar and the drag link cylinder when in the lefthand high angle bank sloping position.

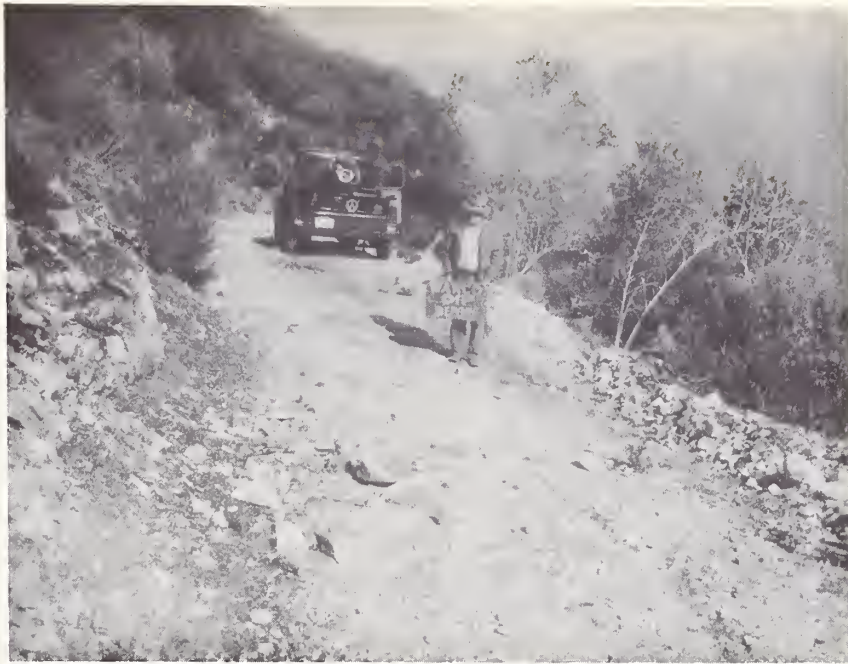
Fig. 28. Road Maintenance - Before

Many photographs were taken before and after the two mile grading test in an effort to record and preserve a basis of comparing operation of the Warco with other units. Photographs, Figure 28 through Figure 33, present before and after shots of the truck trail over which the Warco operated.

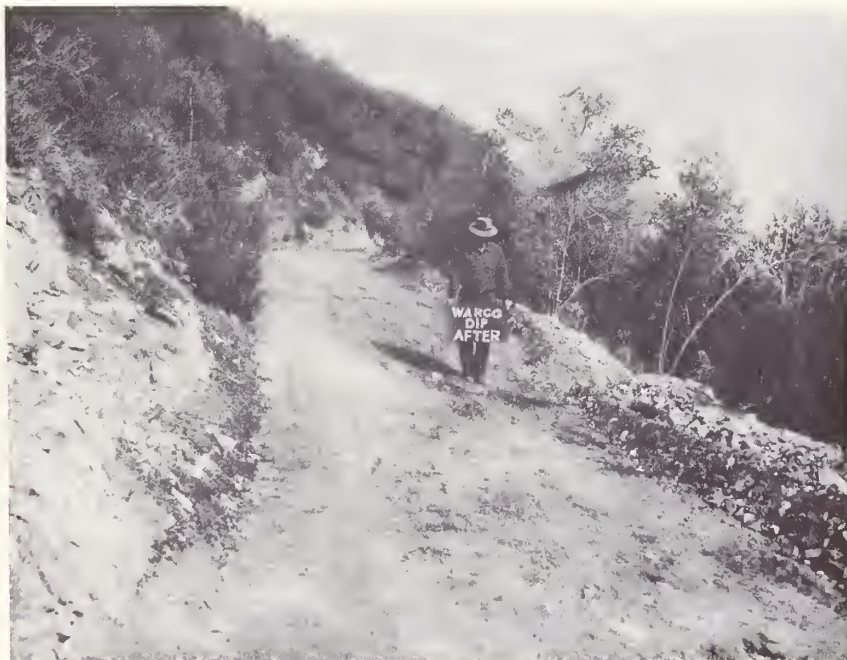
Fig. 29. Road Maintenance - After

Difficulties previously noted were reflected in the results of this run. Corrugated effects on the finished road, low speed troubles, and the others previously mentioned, while present to a degree were considered as not having seriously effected the appraisal.
